**An Assessment of the Effectiveness of Restoration Activities Post-Implementation–
Timberline Proposed Bike Park, Mt. Hood National Forest, OR**

**Jonathan J. Rhodes, Hydrologist
Planeto Azul Hydrology
Portland, OR**

December 2013

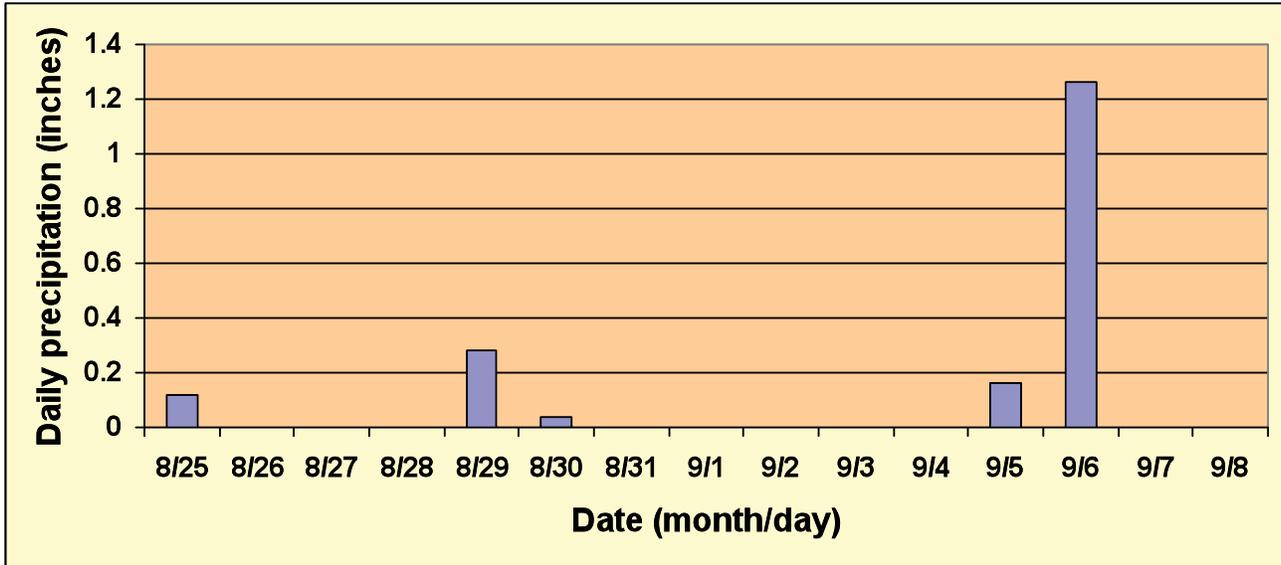
There were several implementation problems on the SNSR. First, the bare, heavily disturbed soils resulting from ripping and resultant loss of vegetation on the SNSR did not receive ample cover to control erosion triggered by the exposure of the bare soils to rain and snowmelt events which occurred prior to the 9/8/13 and 10/21/13 field reviews (Figures 1 and 2).

Figure 1. Daily precipitation measured at the weather station at station at Moen Court, Rhododendron, OR prior to the 9/8/13 field review. While data from this station does not provide a perfect measure of precipitation within the Project Area, it provides a reasonable index of that in the Project Area. It is highly likely that all of the precipitation during period was in the form of rain.

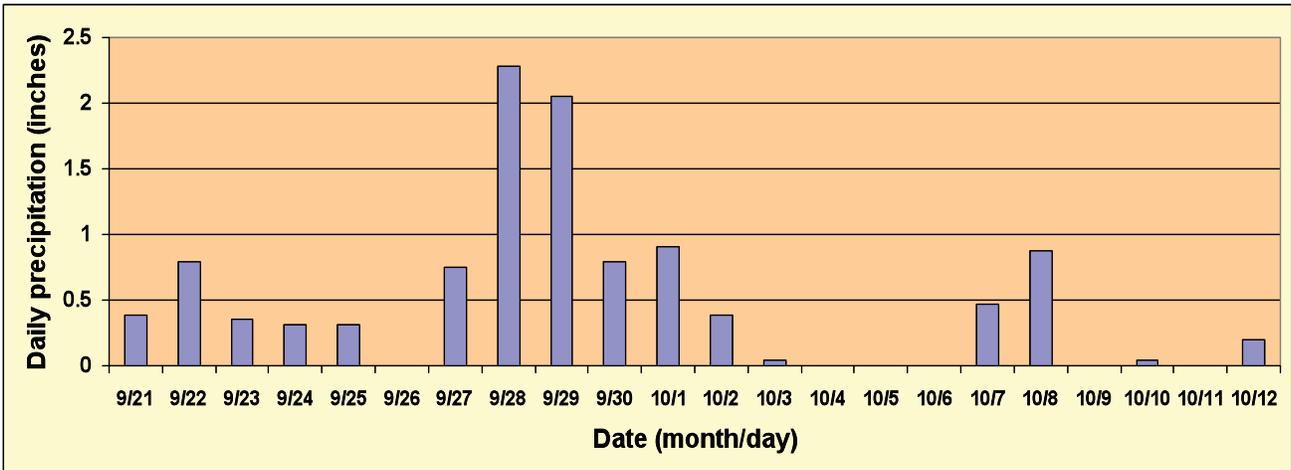
Figure 2. Daily precipitation at the weather station at Moen Court, Rhododendron, OR prior to the 10/21/13 field review. The data from this station provides a reasonable index of that in the Project Area. It is highly likely that much of the precipitation during was in the form of rain, however, some certainly fell as snow, especially in the higher area portions of the Project Area, as webcam images showed significant snowcover in mid-October. There was no precipitation measured at the Moen Court weather station from 10/13/13 through 10/21/13. However, due to weather conditions and snowpack, some snowmelt likely occurred during this period.
